SURVEY OF EARTH-BORNE VIBRATIONS AND THEIR PROBABLE EFFECTS ON PARAMOUNT — DESILU STUDIOS

September 1967

Project W. O. 36411

A SURVEY OF EARTH-BORNE VIBRATIONS
AND THEIR PROBABLE EFFECTS ON
PARAMOUNT-DESILU STUDIOS

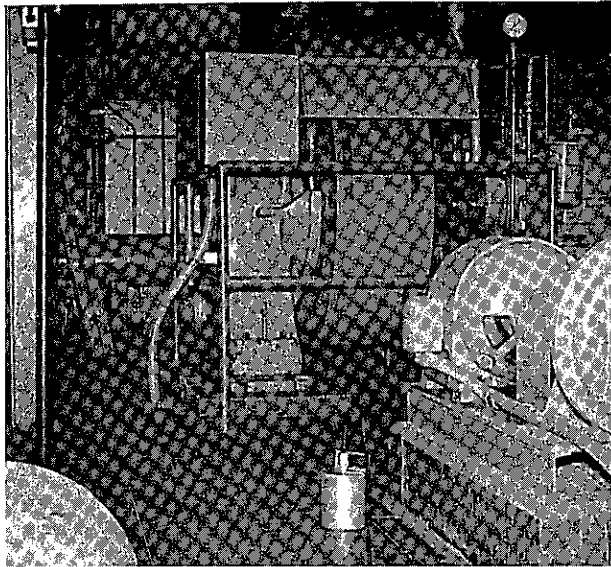
FIGURE 15

The largest in-plant studio vibrations were on the floor of the heating and air-conditioning machinery room. Figure 15 is a photograph of this room showing the seismometer on the floor. Figure 17 shows the heating and air-conditioning room indicated as 101. The vibration inside of this room on the floor was 0.000140 inches. It is to be noted that this was a continuous vibration and not of a transient nature as in freeway vibrations. The vibration on the alleyway (Figure 16) just outside of this room was 0.000200 inches and of a transient nature. The source or nature of this vibration was not determined. Figure 18 is the vibration record for the two locations. A Paramount official had indicated that vibrations from the heating and air-conditioning room have not been a source of problem for them.

View of Seismometer on the Floor of
Paramount's Heating and Air-Conditioning
Machinery Room

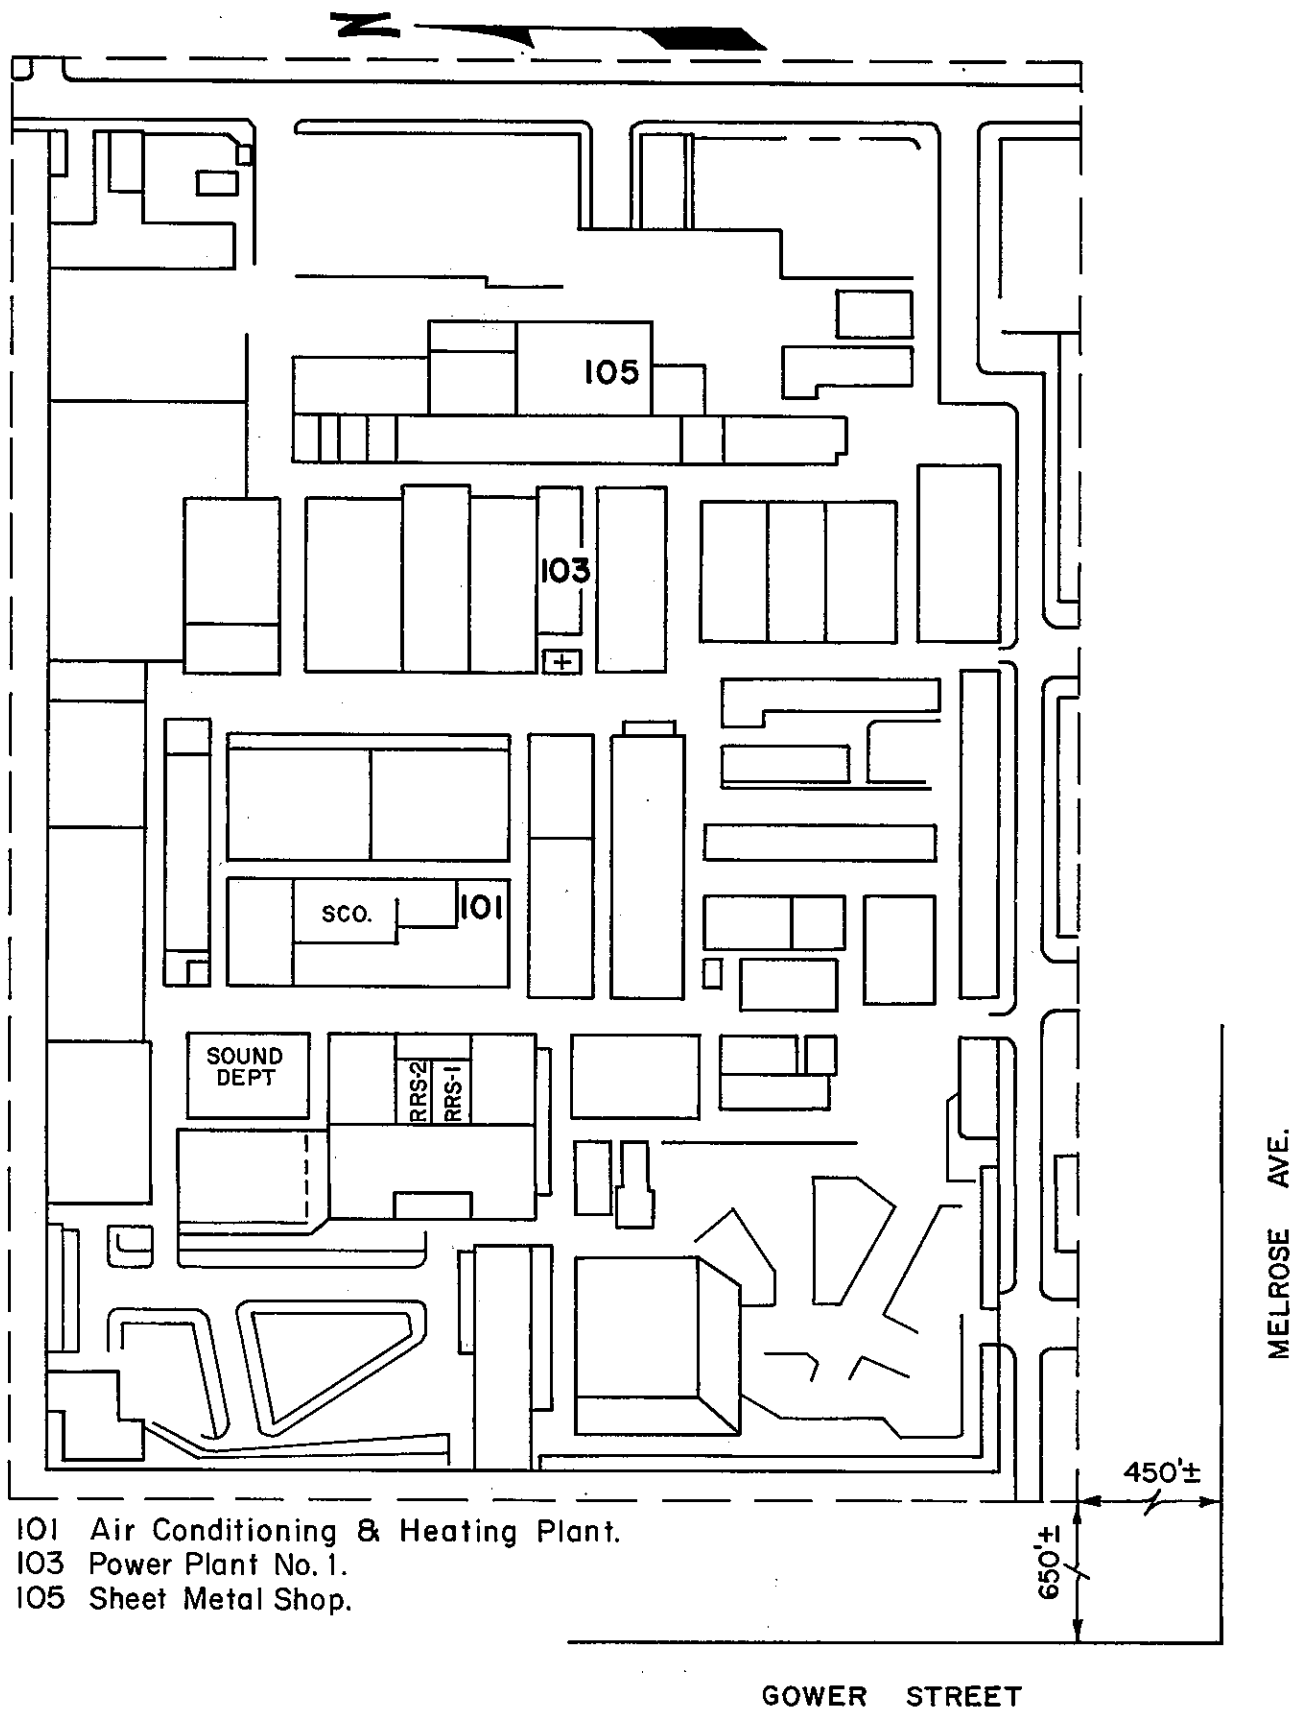
Figure 17

Vibration Test Record Run No. 101
Date: June 15, 1967
Location: Paramount's heating and air-conditioning
 machinery room.
Vibration Source: Machinery in operation.

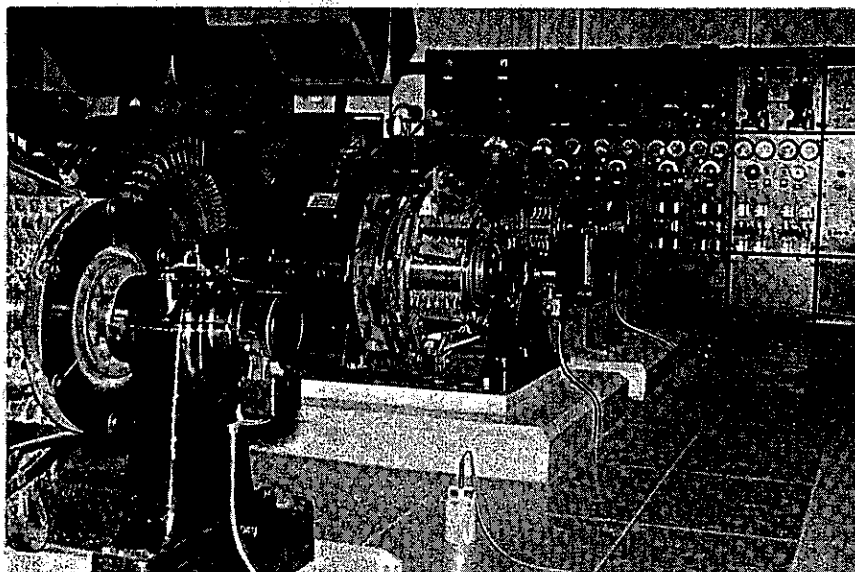
FIGURE 19
Power Plant #1

Vibration measurements were recorded inside of Power Plant #1. The location is shown on Paramount plan layout, Figure 17, Location 103, and also on Figure 19. Vibrations were small and immeasurable.

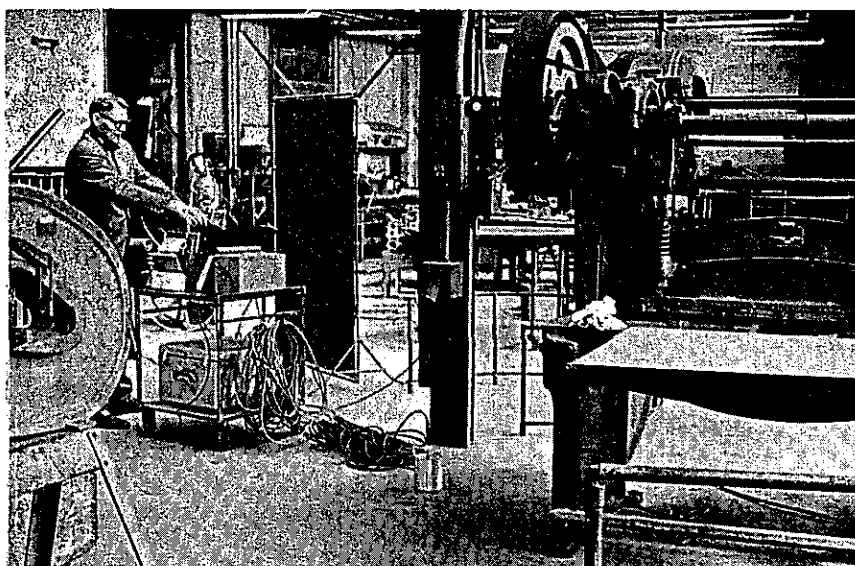
FIGURE 20
Peck, Stow and Wilcox Punch Press

A sheet metal shop was located on Paramount's premises as indicated on the layout, Figure 17, Location 105. A Peck, Stoe and Wilcox punch press, Figure 20, was used to shear a 10 gage sheet of steel while a vibration record was made. A seismometer was located within 3 feet of the press. The vibration record is shown in Figure 21. Vibrations on the floor beside the punch press at the instant of metal shearing was 0.000280 inches.

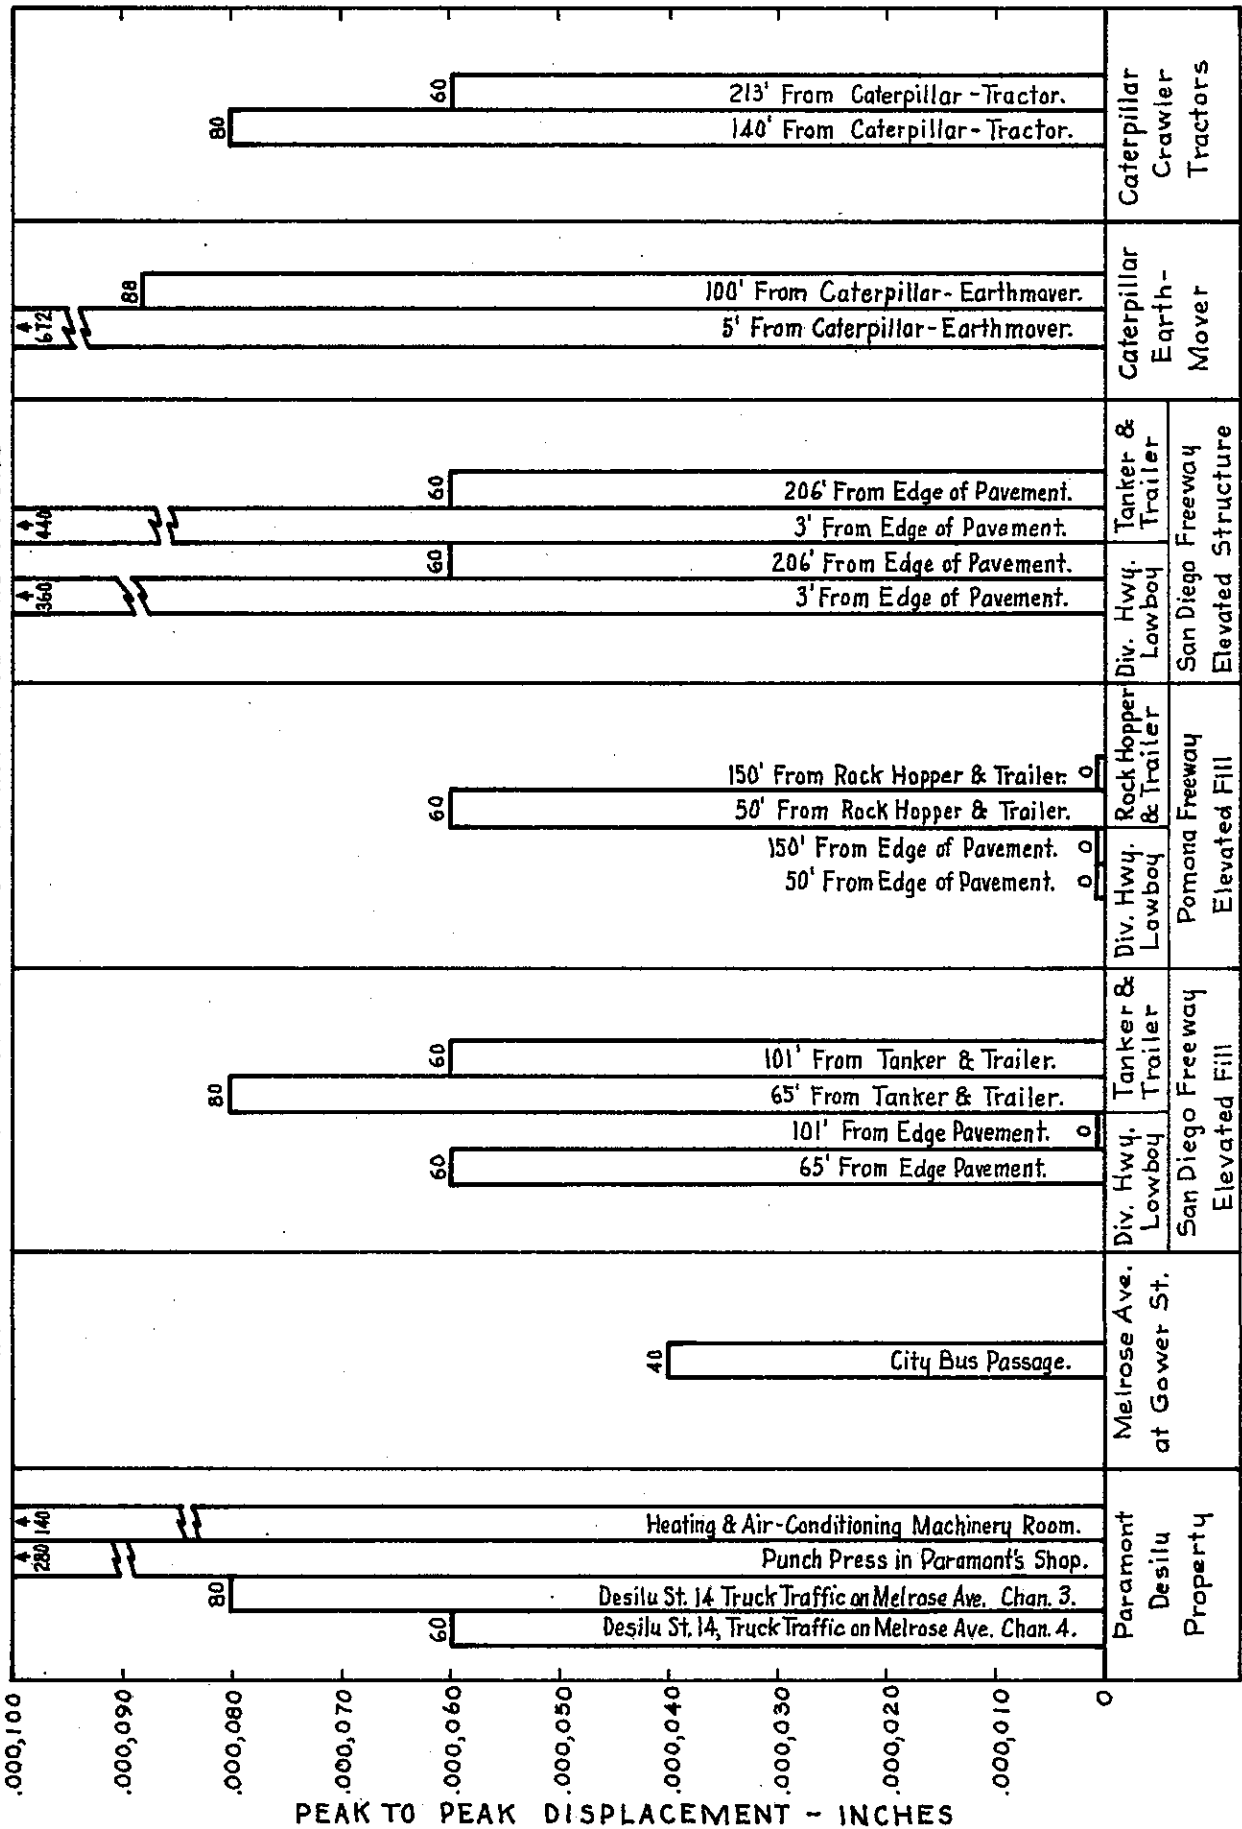
Figure 27 is a bar graph summary of the maximum vibration levels at each of the test sites. With reference to this figure, Paramount-Desilu Studios will not be affected by construction vibrations during the building of the Beverly Hills Freeway with a separating distance of 350 feet from the freeway outer edge to the nearest studio corners. This is based on measurements of 0.000088 inches emanating from a Caterpillar earthmover at a distance of 100 feet and 0.000060 inches emanating from a series of Caterpillar tractors at a distance of 213 feet. It is reasonable to assume that the above displacement vibrations will have dropped off to a negligible value at a 350 foot distance. In addition, 0.000140 inches of displacement vibrations were measured inside of Paramount's machinery room, a value much larger than from the above construction equipment at the noted distances.

However, vibrations emanating from the realignment construction of the city streets (Gower, Melrose, and "XYZ" Streets) within a 200 foot distance may be felt by the studios. Vibrations measured inside of Desilu East Studio 14 emanating from current local street traffic on Melrose Avenue and Gower Street were equal to the vibrations (0.000060" - 0.000088") emanating from construction equipment at a distance of 200 feet. This level of vibration was barely perceptible by our engineers inside of Studio 14. Therefore, since the studio can tolerate the present level of vibration emanating from Melrose Avenue traffic, vibrations emanating from the construction realignment of the city streets within a distance of 200 feet will not add to or raise the present level of Studio 14's background vibration.

PARAMONT-DESILU VIBRATION SURVEY
MAXIMUM VIBRATION LEVELS AT INDICATED LOCATIONS

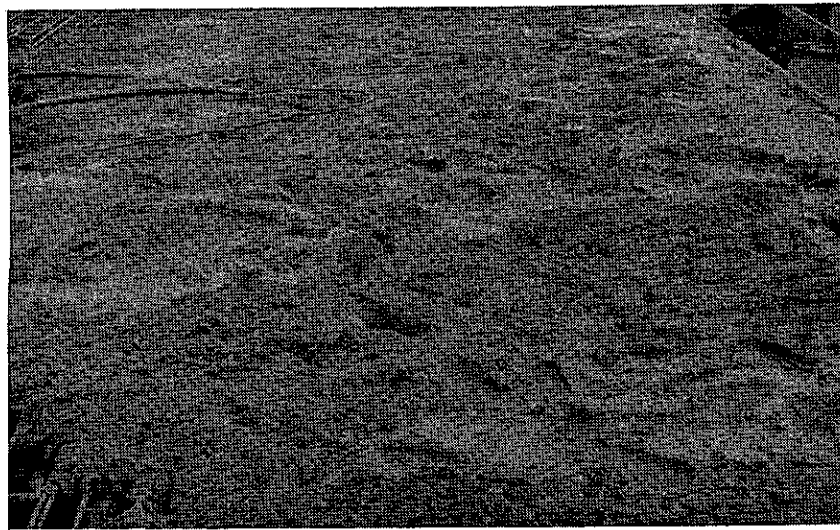
Fig. 21.

Excessive walking
in the fresh
concrete

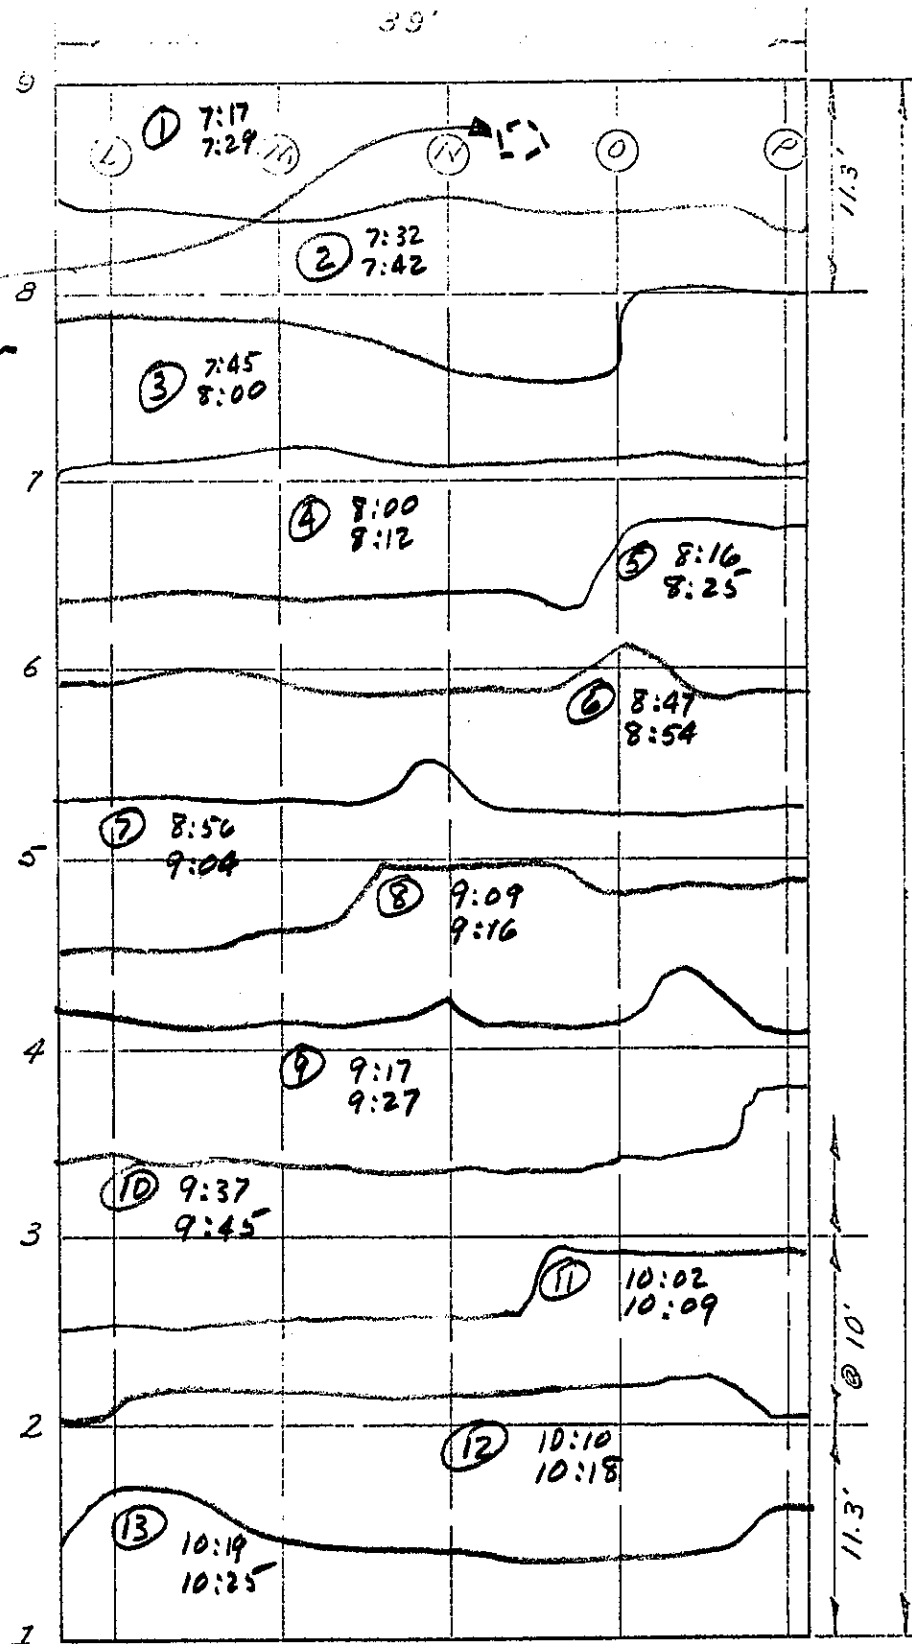
Placing

Left vibrator
running for
about 30 sec.

Moved crane
between loads
5 & 6

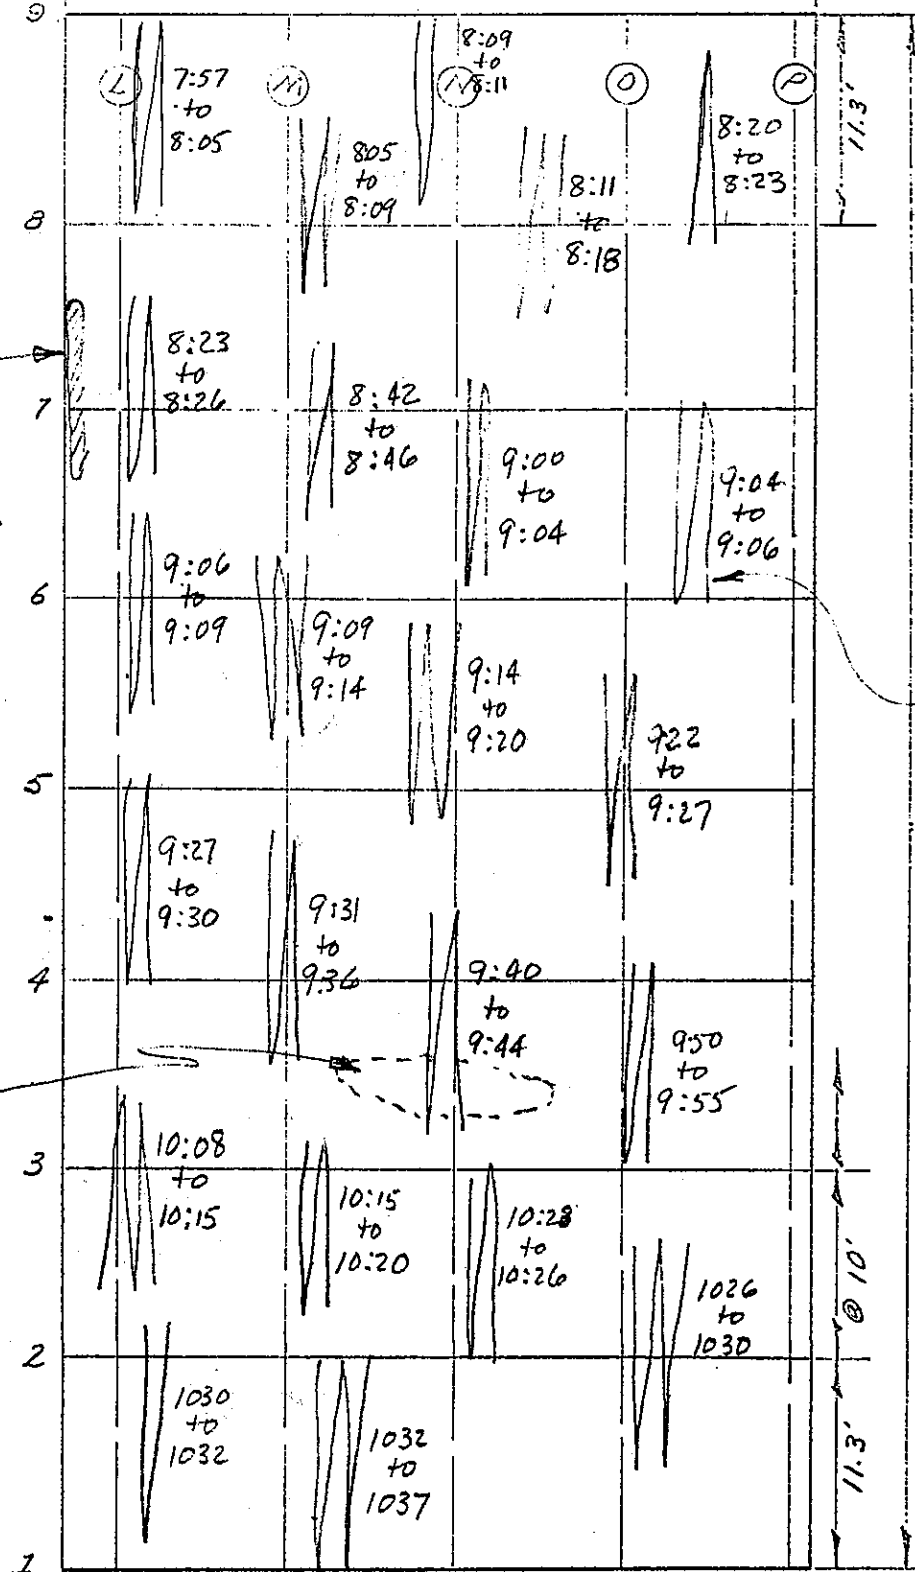
Strike-off

Excessive
foot prints in
the mud. (Minor
repair to
Bidwell.)

First & last
3' struck-off
with 2x4
